GILES COUNTY
PUBLIC SCHOOLS

DIVISION WIDE FACILITY STUDY DECEMBER 2022

Crabtree, Rohrbaugh & Associates - Architects

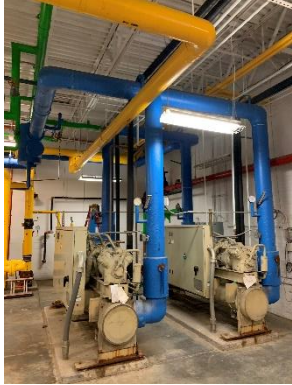
Existing Chillers

The existing central plant is made up of two 97.5-ton split DX air-cooled chillers and two 1,600MBH natural gas boilers. The chillers, boilers, and associated pumps are located in the lower-level main mechanical room adjacent to the gymnasium, and the split DX condensers for the chillers are located on the roof above the gym storage area. A majority of the central plant equipment is from the previous 1999/2000 HVAC renovation that replaced the old coal-fired steam boiler system and unit ventilators.

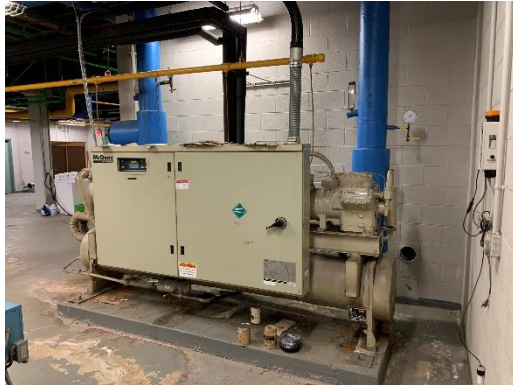
Existing Chiller

The existing central plant is made up of one 133-ton split DX air-cooled chiller and two 1,200MBH natural gas boilers. The chillers, boilers, and associated pumps are located in the lower-level main mechanical room adjacent to the gymnasium, and the split DX condensers for the chillers are located on the roof above the gym storage area. A majority of the central plant equipment is from the previous 1999/2000 HVAC renovation that replaced the old coal-fired steam boiler system and unit ventilators.

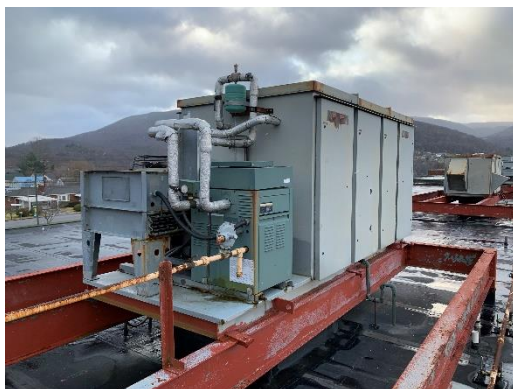
Typical Built-Up DOAS

and a hot water heating coil. The units are installed on exterior structural dunnage that also supports a split DX condenser and natural gas-fired heating water boiler. Each DOAS unit has its own dedicated split DX condenser and heating water boiler which is a maintenance issue which should be addressed no matter the final central plant solution that is chosen.

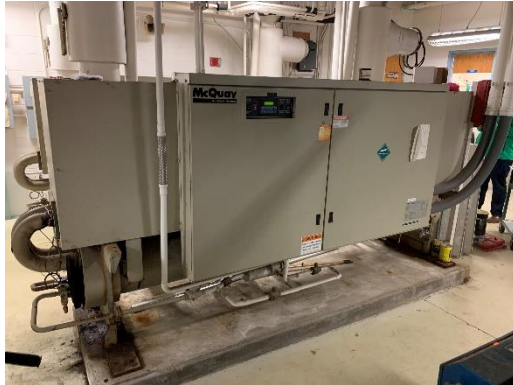
Existing Chiller – 1 of 2

The existing central plant is made up of two 130-ton split DX air-cooled chillers and two 2,300MBH natural gas boilers. The chillers, boilers, and associated pumps are located in the lower-level main mechanical room adjacent to the gymnasium, and the split DX condensers for the chillers are located on the roof above the gym storage area. A majority of the central plant equipment is from the previous 1999/2000 HVAC renovation that replaced the old coal-fired steam boiler system and unit ventilators.

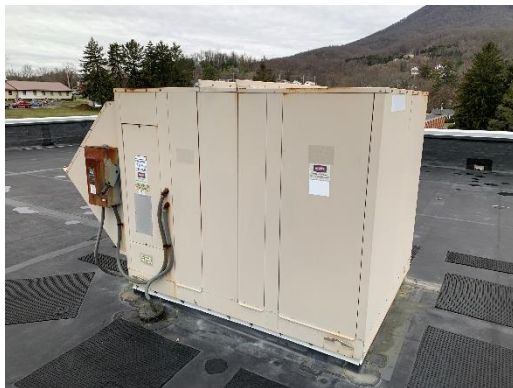
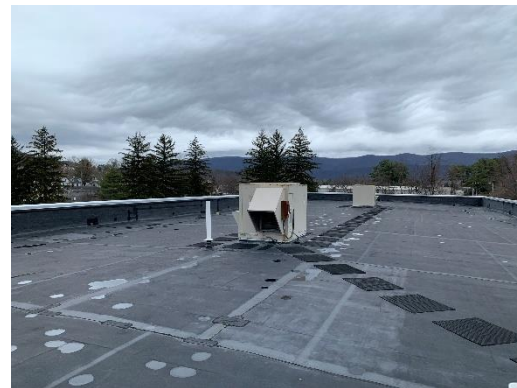
Typical ERV

A majority of the ventilation air for the school building is provided by dedicated rooftop energy recovery ventilators that were installed during a previous HVAC renovation. The units are Des Champs PVEZW units that have a total enthalpy wheel, a supply fan, and an exhaust fan. The units are installed on standard roof curbs. The ERVs cannot adequately control temperature and/or humidity as there are no active coils in the unit which could help to reduce humidity in the air, which can lead to issues within the occupied spaces and this should be addressed no matter the final central plant solution that is chosen.
